SELECTED DESIGN NOTES

LANDING GEAR — Hydraulic Brake Control Valve

Corrosion Caused Frequent Readjustment of Brake Control System

BULLETIN NO. 55-11

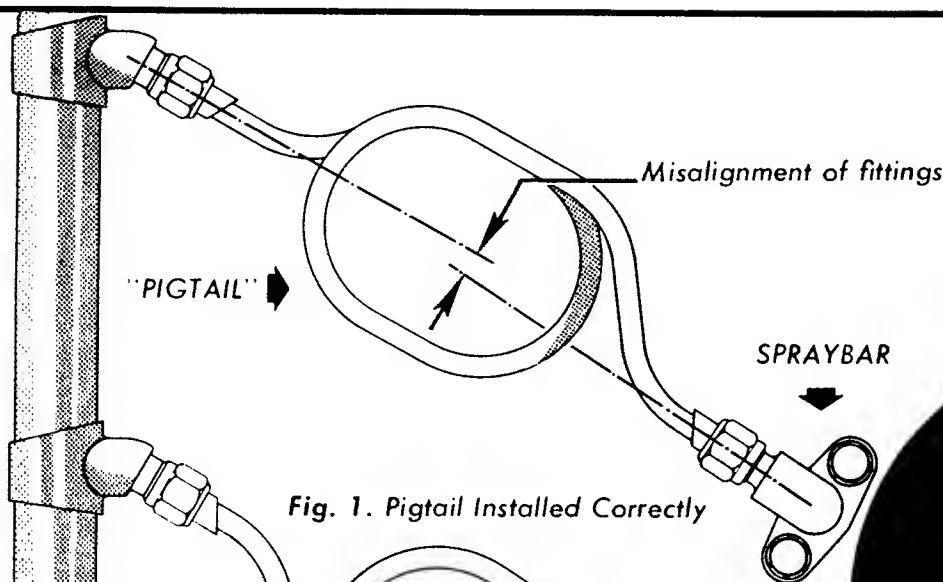
Fig. 1. Pigtail Installed Correctly

FIRE AND EXPLOSIONS in the afterburner section of fighter type aircraft occur due to fuel leaking from "pigtail" connections to the afterburner spray nozzles. Leakage is caused by cross-threaded B nut connections resulting in stripped threads, and frequent breakage of the tubing where it is silver soldered to connector ferrules.*

BOTH CROSS THREADING OF THE B-NUTS and broken tubing of the pigtail connectors result from the existing misalignment of the spray bar and fuel manifold connections. They are just enough out of line to escape the notice of a mechanic not thoroughly familiar with the situation, and permit the pigtails to be installed in reverse. When this is done, threads are likely to be stripped and the soldered joints crack open due to the excessive bending stress on the joint caused by forcing the tube into place. Each engine has 24 pigtails; 48 chances of a leaky connection.

It is not clear why the existing condition could not be alleviated by substituting a flexible metal hose for the present rigid pigtail.

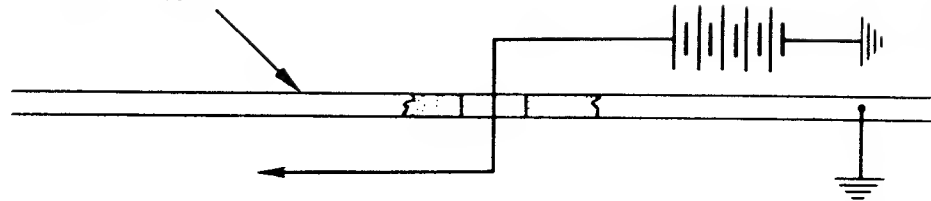
TEN YEARS HAVE PASSED since the original Design Note on this subject was issued. Since the identical design deficiencies continue to show up in electrical equipment of the latest jet aircraft and missiles, it is evident that these small but important details are being overlooked either through carelessness in design or lack of "know-how."

Fig. 1. THE PROBLEM: To conduct current to opposite side of the metal plate without danger of grounding.
